# TREATING URBAN STORMWATER IN CONSTRUCTED WETLANDS IN KALMAR, SWEDEN, FOR IMPROVED WATER QUALITY AND BIODIVERSITY

Jan Herrmann Miku Yoshiyama

Department of Biology and Environmental Science, Linnaeus University, Kalmar, Sweden Corresponding author: <u>jan.herrmann@lnu.se</u>

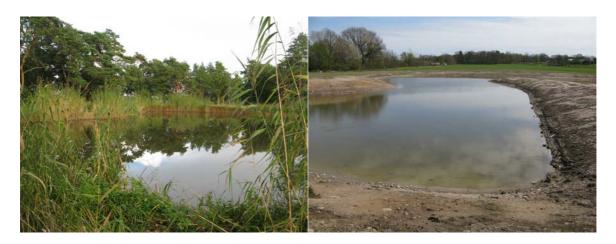
*Figure 1. The studied pond systems; (a) Skälby Dämme 2011-09-08 (11 years old), and (b) Hagbygärde Dämme 2012-05-08 (3 months old).*

Skälby Dämme (SkD), in fact a three-pond system with a channel in between these, in total of 1 ha area, receives water from mainly residential and traffic areas, and is located where was earlier "woody wetland", thus surrounded by trees and bushes (*Figure 1a*). The pond system was functioning from May 2000, was evaluated 2002-2004 for water chemistry (first year monthly sampling, then less frequently, always inlet and outlet of the system), but earlier start for monitoring the colonization of benthic invertebrates (handnet samples, four sites, nine times over 2.5 years) and littoral plants, once each the four first years [1]. The same program was repeated during one year 2011-2012, using the same sampling locations, frequency and chemical and biological parameters. At this time also three seine nets were used during one night, in order to screen the fish community in the pond system. Bird observations for all years were assembled. For both study periods, the standard nutrient parameters and five metals were analysed (*Table 1*), and also the reductions of these through the pond system were calculated, even if with some uncertainty for the early period (SkD 1).

giving higher loads with nitrogen and metals, but lower with phosphorous (*Table 1*). HaD is located/excavated on earlier arable, grazing or impediment areas, but quite little of woody land (*Figure 1b*). Water samples were taken from October 2012 to December 2013, at inlet and outlet of the system, and analysed for mainly nutrients and metals (*Table 1*). The colonization of benthic invertebrates was monitored by hand-net sampling eight times over 1.5 years, at five sites. Aquatic plants were surveyed mainly in Sept/Oct 2013, and bird observations were assembled from ornithologists [2].
